THE GREKUL HOUSE: A Land Use and Structural History

Occasional Paper
No. 14

Demjan Hohol'

March 1985

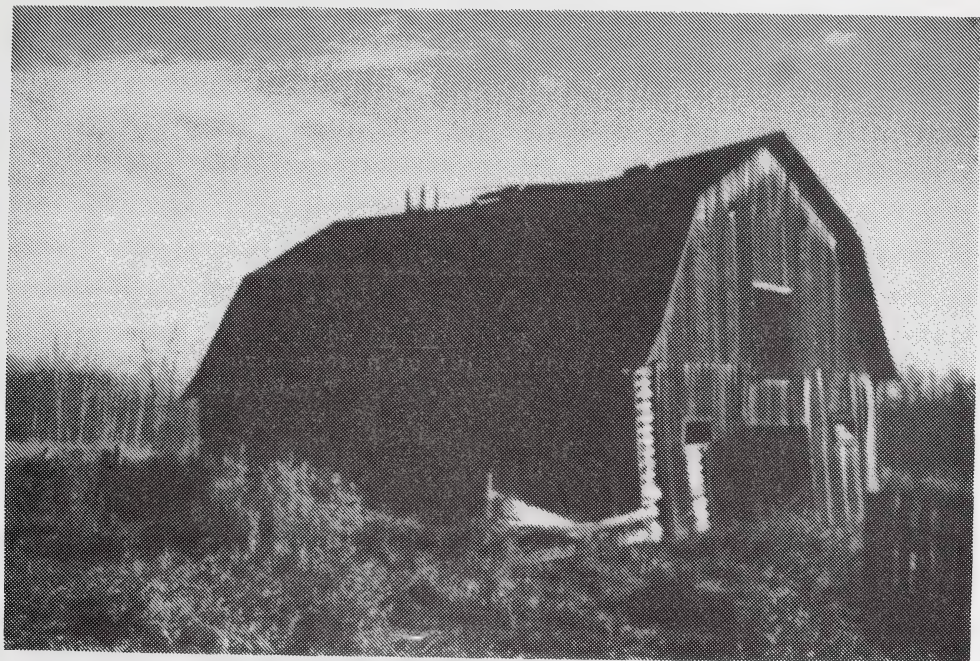
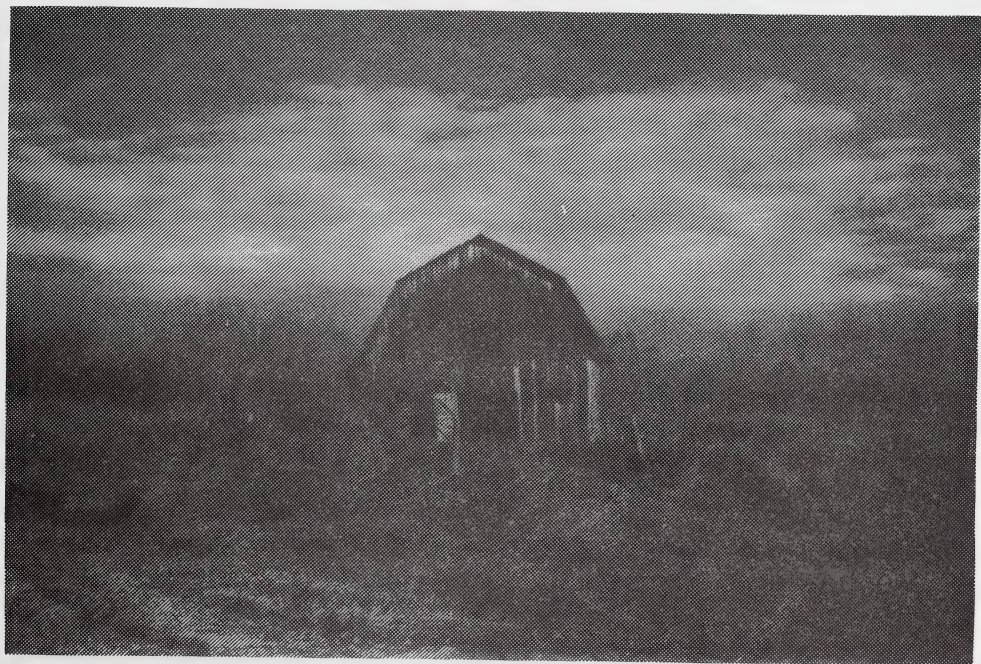
Fig. 14. The stáinia (large barn) built for Nykolai Grekul by Petro Hutsul-Rizun in 1915. Photographs by Demjan Hohol', October 26, 1983.

In 1915, at the time of Vasyl Grekul's wedding, a stainia (large barn) was being built by Petro Hutsul-Rizun,⁷⁷ east of and downhill from the large house. The stainia had a gambrel roof, which allowed for the storage of hay and straw in its spacious loft (see Fig. 14). A corral was built to the south and west of the structure. Six-inch thick "slupky" (posts) were set into the ground at approximately twelve foot intervals, and interconnected with three or more "vorynia" (rails) nailed horizontally across the posts. The "vorynia" were about four inches in diameter, and flattened on one side. The first rail was placed approximately two feet above the ground, and the rails above them were spaced about one and one-half feet apart. A large gate was located on the west side of the corral, directly in front (south) of the barn.⁷⁸

After Hryhorii's death in 1969, Axenia moved into Smoky Lake with her nephew, John Wolansky, who continued to farm the land. Although Axenia continued to keep a garden north of the large karnyk for a few years after her husband's death, the yard, like the large house, was allowed to deteriorate.¹³⁵ No buildings were intentionally destroyed, but as they no longer were being used, no effort was made to maintain them. The "karnyky" were the first buildings to collapse, soon followed by the west wall and ceiling of the khatyna. The modernistic kurnyk (chicken coop), and the beautiful "shpykliar" (granary) were still in good repair in the summer of 1983, but the stainia (large barn) was beginning to cave in (see Fig. 14).¹³⁶

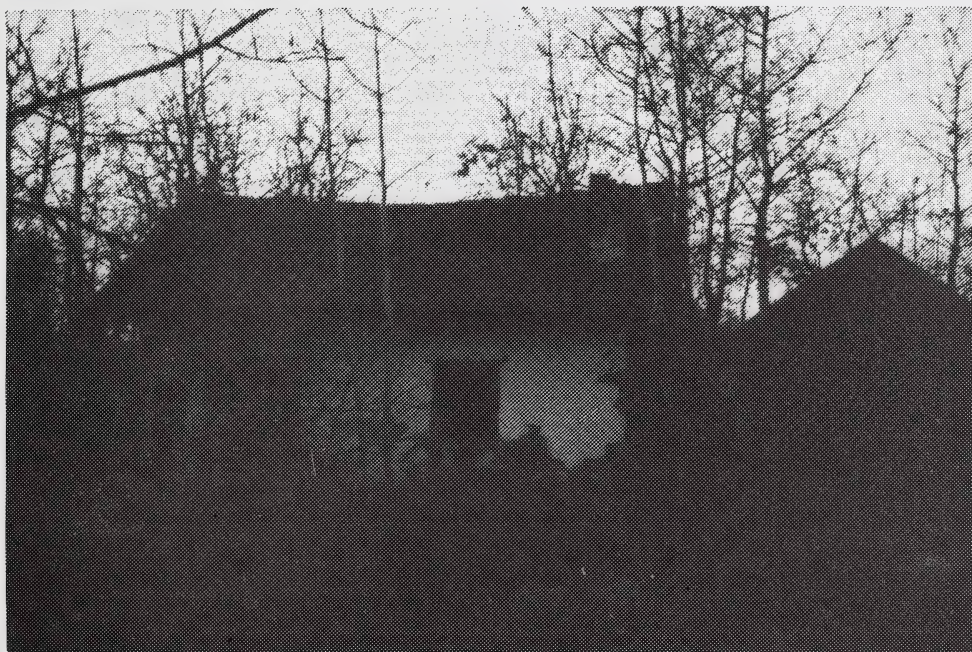
Fig. 16. The khatýna (one-roomed house) built for the Grekuls by Mytro Pirnak, c. 1920. To the right of the khatýna stood a granary-turned-summer kitchen, built sometime later, but before 1945. Photograph by Demjan Hohol', October 26, 1983.

Shortly after their marriage, the khatyna (small house) was knocked down and replaced with a new khatyna built by Mytro Pirnak (see Fig. 16). As it was intended for the comfort of Hryhorii's parents,¹¹⁴ the new khatyna must have been built between 1918 and 1920, thereby constituting one of the first major changes made to the Grekul homestead by Hryhorii and Axenia. This building was oriented to the east, facing the yard. Like the house, its roof was shingled with "gonty" (wooden shingles), its walls were of zrub (horizontal log wall) construction, plastered and whitewashed. It is not known if its red brick chimney was constructed immediately, or at some time later in this period. The roof shape differed from that of the large house and "shpykliar", as it was a two-sided roof with short eaves. This shape was known in Ukraine at the time, but it was uncommonly used.¹¹⁵ Therefore, it seems likely that this roof type was adopted in order to appear "modern" and Canadian.

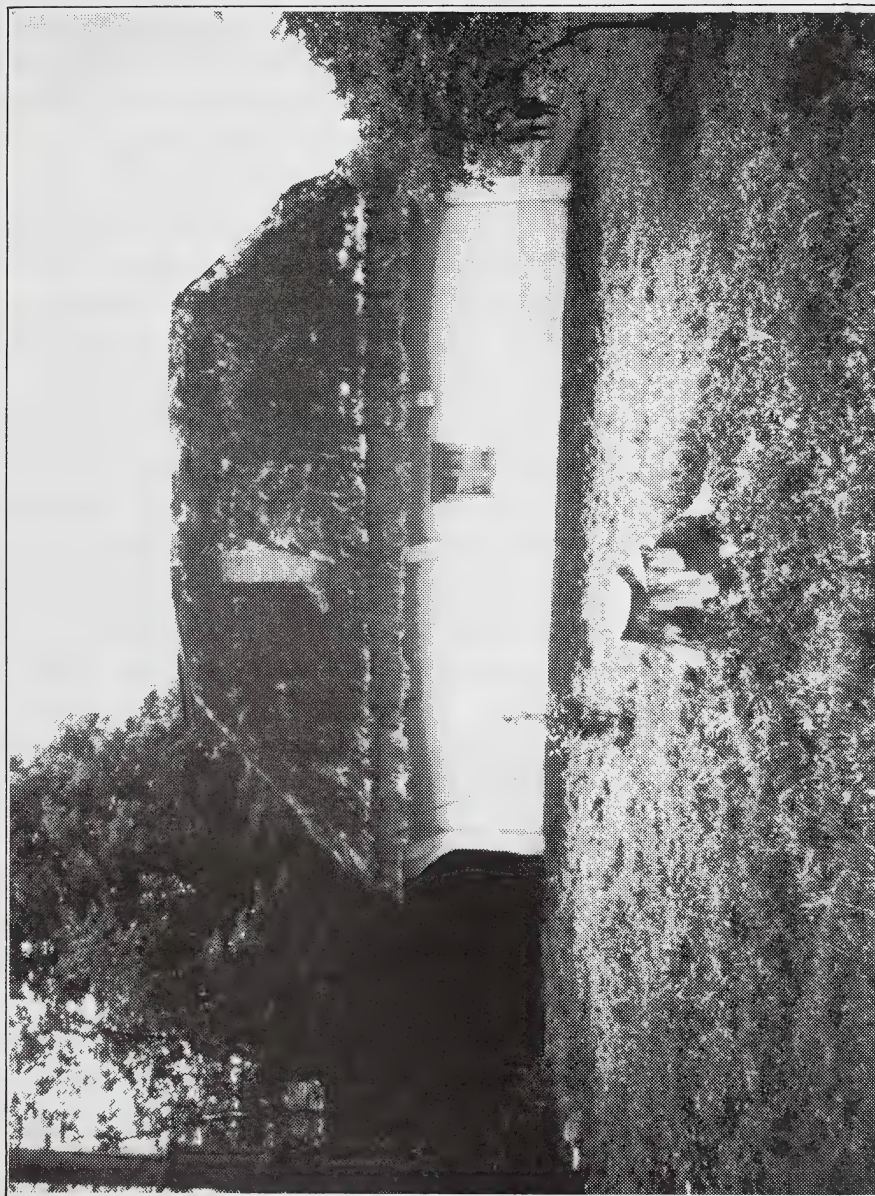
Fig. 22. A house in Shypyntsi, Bukovyna. The height of the prysba (clay enbankment), the placement of a window in the north wall due to the location of a road north of the yard, and the whitewashing are similar to features of the Grekul House. Photograph by R. Bilash, 1983.

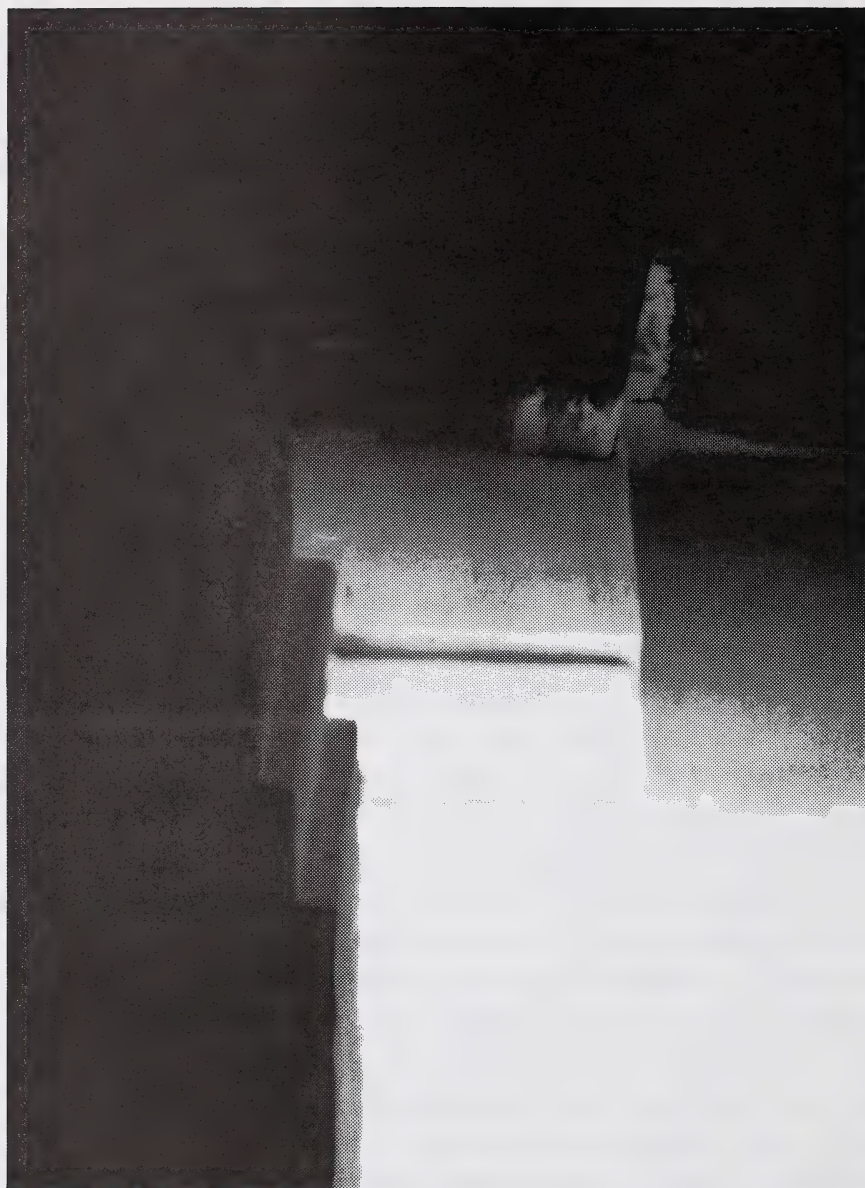
Fig. 23. The south-west vuhla (cornice bracket) of the Grekul House. Photograph by R. Bilash, 1978.

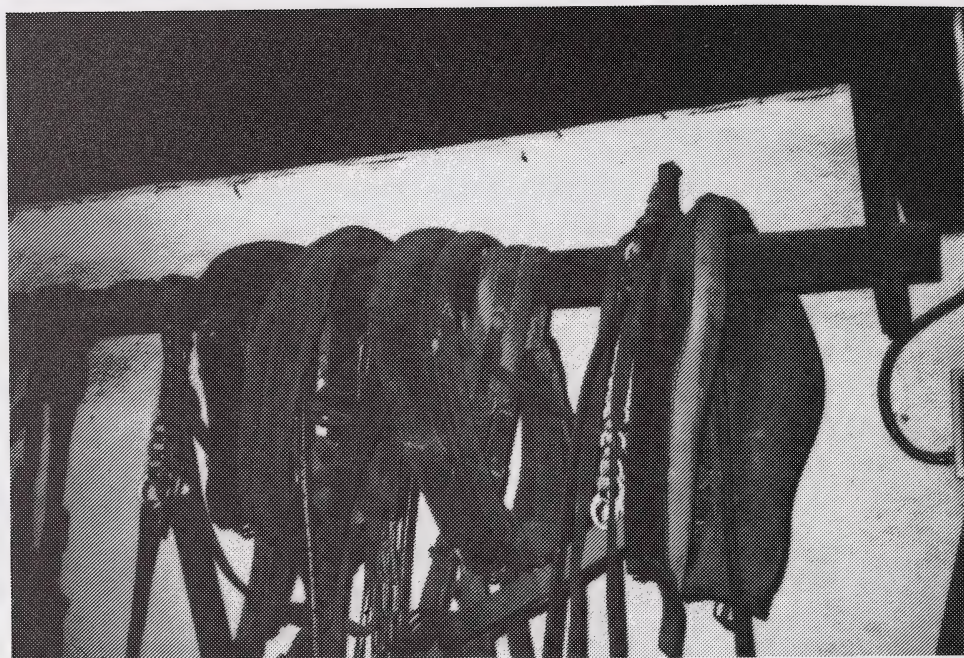
Fig. 26. A very sturdy zhérdka (hanging rail) located in the north-east corner of the velýka kháta (big room) of the neighboring Harasym house (SW 30 59 16 W4).

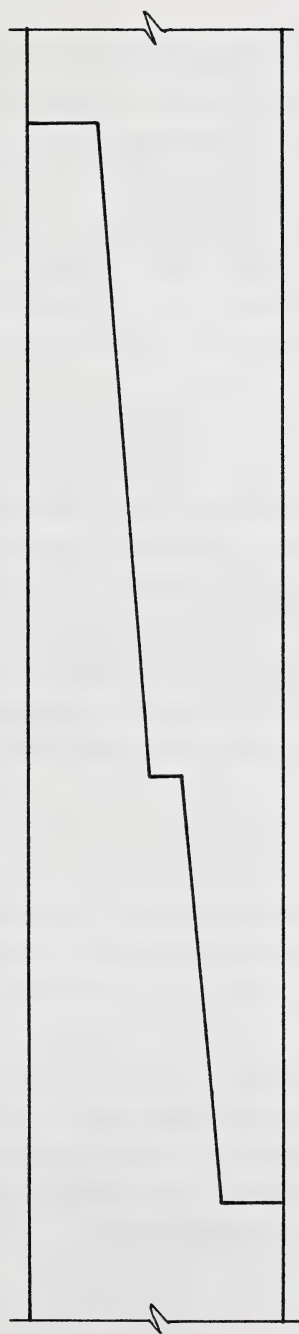
Fig. 32. The sleeve joint used in the pozdovzhni platvy (longitudinal rafter plates) of the Grekul House, in order to tie two shorter beams together and thus create one long beam. Original drawing by Olga Horobec, March, 1984.

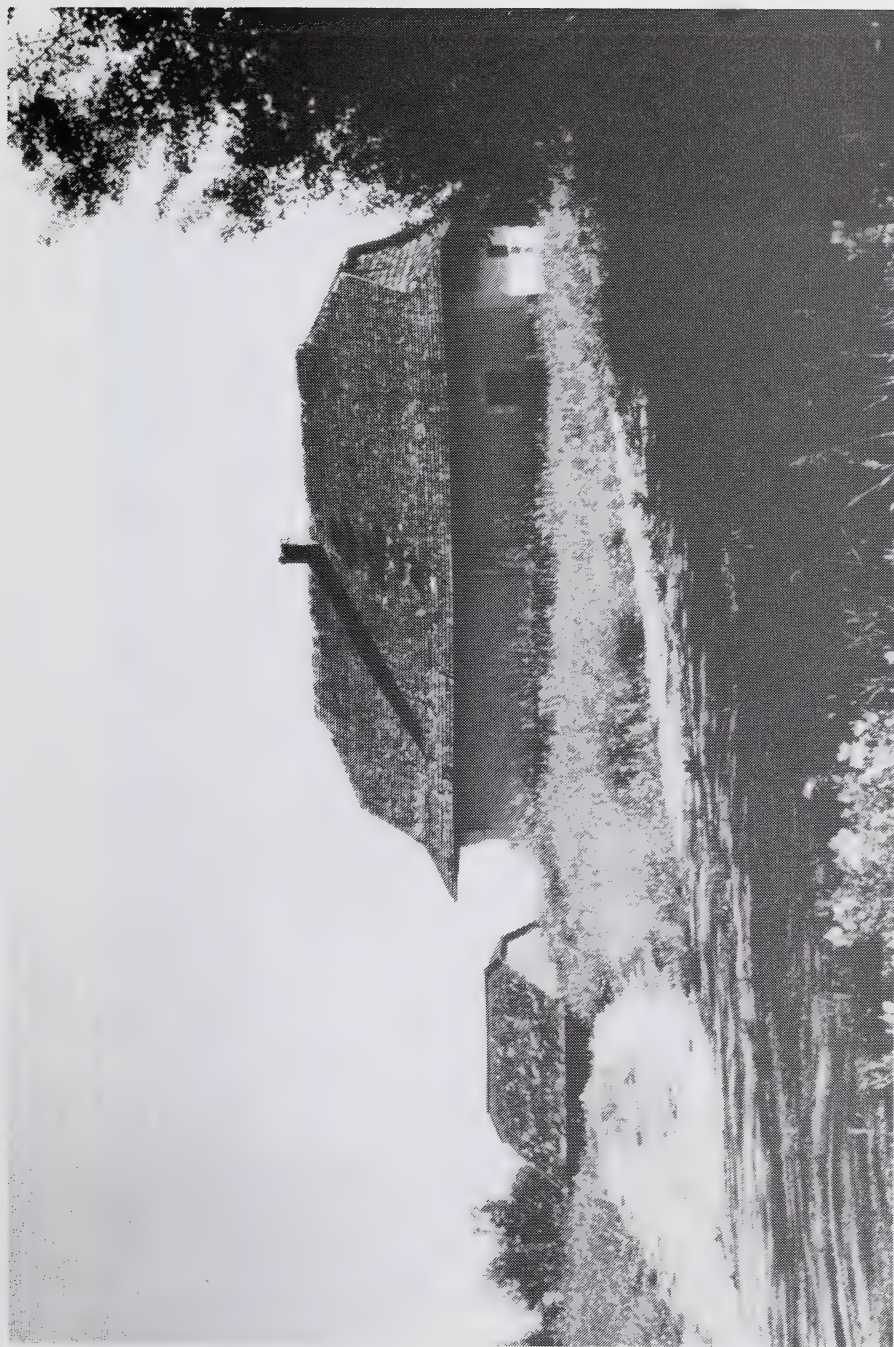
Fig. 40. The north facade of the Grekul House, which had deteriorated greatly by the summer of 1973. The building of Highway 28 in the 1960's lowered the elevation of the former line road, giving the house the appearance from the highway of sitting higher than it had formerly. Photograph by P. Shostak.

- Figure 40: The north facade of the Grekul House, which had deteriorated greatly by the summer of 1973. The building of Highway 28 in the 1960's lowered the elevation of the former line road, giving the house the appearance from the highway of sitting higher than it had formerly. Photograph by P. Shostak 143

The yard and garden were taken over by natural vegetation as the brush around the yard expanded beyond its earlier perimeters (see Fig. 40-41).¹³⁷ The fruit trees of the west garden continued to be harvested by Axenia Grekul and neighbors for a number of years after 1969, until becoming overgrown and consequently less productive than they once were.¹³⁸
